Manhole Inspection Summary

Manhole # S21EE2017MH

Insp Date: **11/17/06 9:21 AM**

Location Address: **1211 CLARKS HILL**

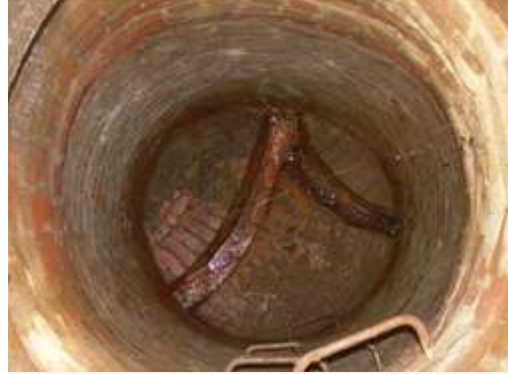
Top View

Evidence of surcharge - Bench debris.
Corroded steps.

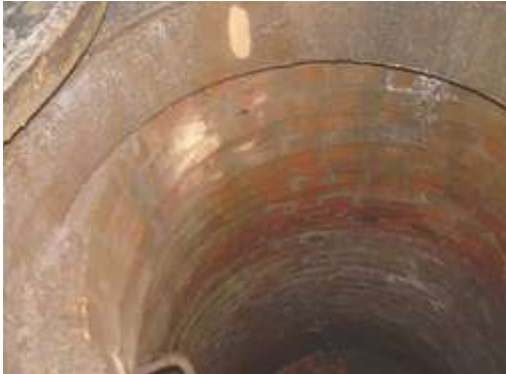
Defect

Offset: **4** (in.)

☒ **Leaks**

Frame leaks. Frame offset. Adjustment,
Corbel, and Barrel infiltration.

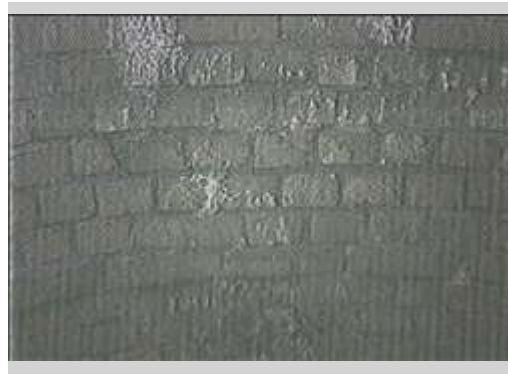
Defect

Condition: ☐ Sound ☐ Cracked ☐ Root Intrusion ☐ Loose Brick ☒ **Deteriorated**

Infiltration: ☐ None ☐ Joint ☐ Cracks ☒ **Mortar** ☐ Roots ☒ **Wall**

Barrel deterioration and infiltration.

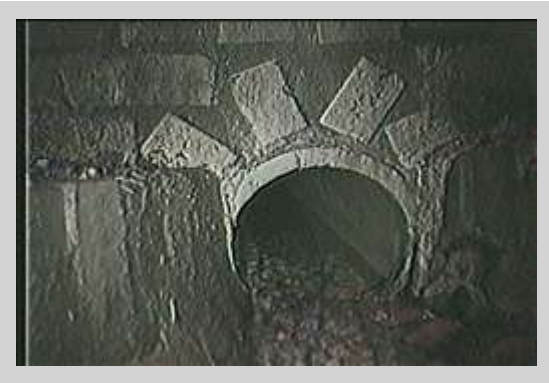
8 in. Circular Gravity Sewer Pipe Out @ 12 O'Clock

Deposits: ☐ None ☐ Mud ☐ Sludge ☒ **Debris** ☐ Grease

Silt Depth: **0.5** (in.) Deposits Extent: **Light**

Infiltration: **Evidence** Pipe Seal Cond: **Unknown**

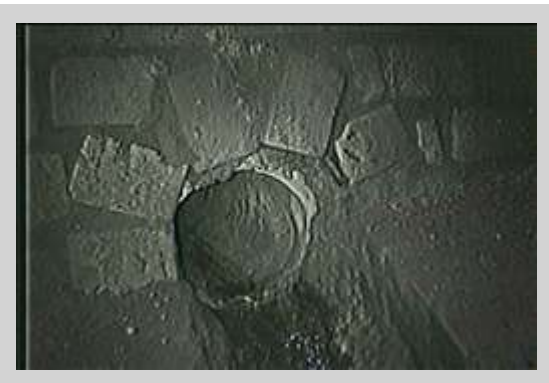
6 in. Circular Gravity Sewer Pipe In @ 4 O'Clock

Deposits: ☐ None ☒ **Mud** ☒ **Sludge** ☐ Debris ☐ Grease

Silt Depth: **0.5** (in.) Deposits Extent: **Light**

Infiltration: **Evidence** Pipe Seal Cond: **Unknown**

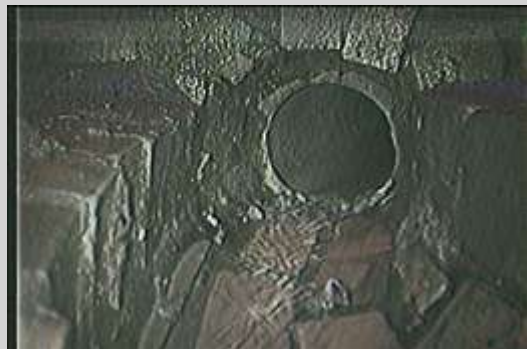
Pipe In @ 7 O'Clock

Infiltration: **Evidence**
